COMMONWEALTH OF KENTUCKY
BEFORE THE PUBLIC SERVICE COMMISSION

LOUISVILLE GAS AND ELECTRIC COMPANY)	
)	
_____)	CASE NO. 97-174
)	
ALLEGED VIOLATIONS OF ADMINISTRATIVE)	
REGULATION 807 KAR 5:041)

UTILITY ACCIDENT INVESTIGATION REPORT

INVESTIGATION REPORT

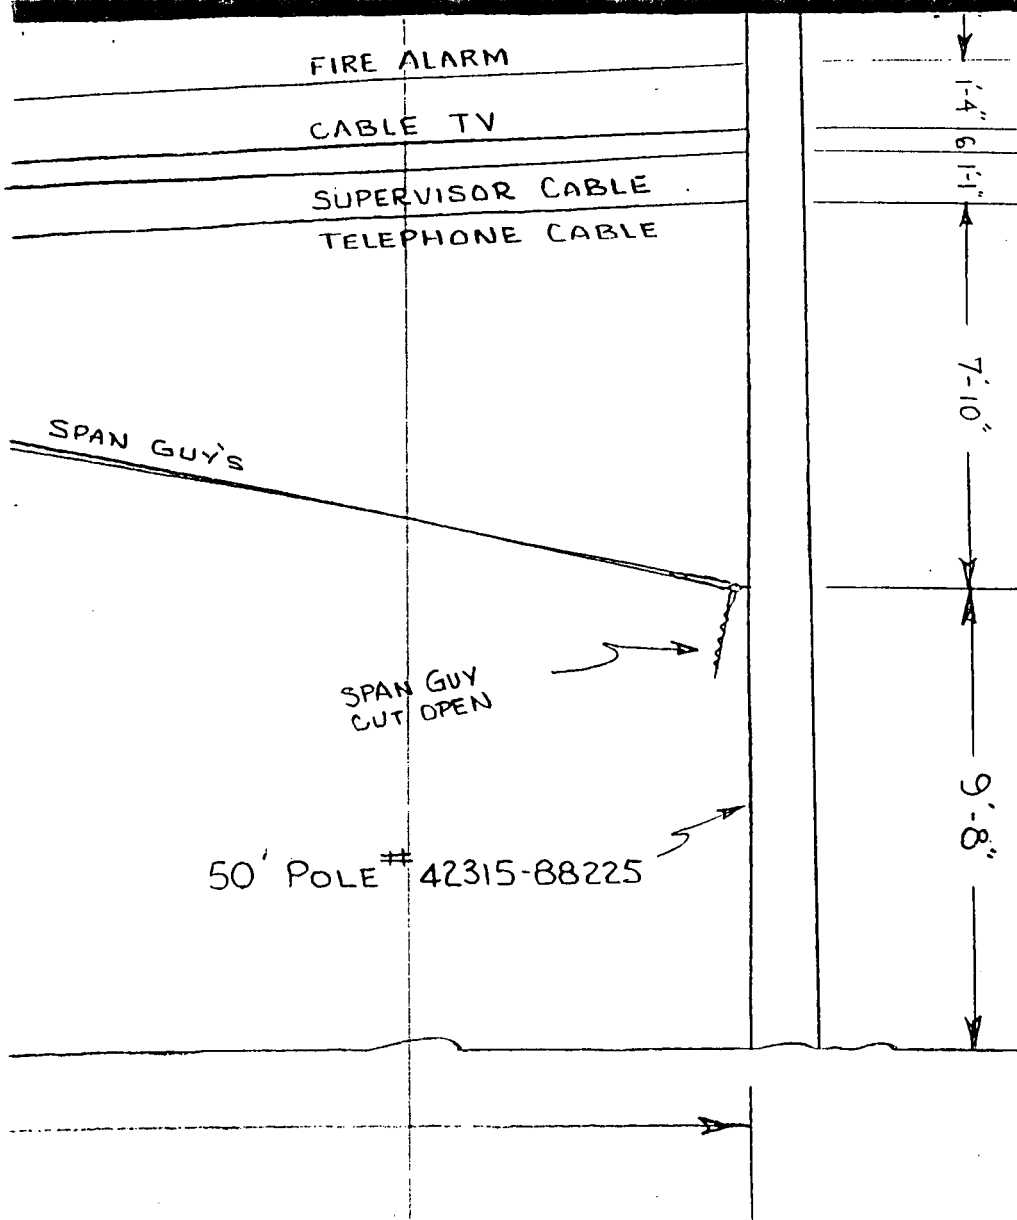
SKETCH SHOWING POLE # 42315-88225
 AND POLE # E2-2468 IN FRONT OF
 1020 W. MARKET ST. WHERE ACCIDENT
 OCCURED TO CHARLES SHEARD 10-16-96
 NO SCALE DRAWN BY R.W. HASCH

The following conditions were noted. A light standard located on the south side of Market Street between poles #E2-2467 and #E2-2512 had a disconnected wire on its west side. This wire is fed by an incandescent lighting circuit "tub" located on pole #E2-2468. This pole was in the process of being replaced and a new pole was set on the east side of it on October 16. Extension arms were attached to pole #E2-2468 to spread the wires (a normal procedure for pole replacement). The lower extension arm held the end of a 240 V secondary line, and a guy wire holding it in place. The other end of the guy was attached to pole #E2-2467 (where two other guy wires also attached from pole #E2-2468). The guy wire in question was removed on the evening of October 16 by Kevin Rhodes, Line Technician-Trouble. LG&E's correction order #827859 states, "Found temporary head guy laying on incandescent circuit and burning on ground. Cleared up okay." (Note: Notation of "temporary" on correction order was an error. Head guy was permanent.)

There are two trees involved in this incident. The larger tree, directly in front of 1020 West Market Street, is the one Mr. Sheard advises he touched, and a smaller tree, which is located just west. The larger tree has limbs which have grown into the incandescent wire. The smaller tree suffered fire damage on the evening of October 16. All that remains of the smaller tree is a burned stump. The fire department removed the rest of the tree on October 16. The concrete on the sidewalk surrounding the stump of the small tree contains several burn marks. According to Mr. Hasch, these are indicative of incandescent circuit voltage.

The incandescent lighting circuit would not have been energized on October 16 until dark when the photocell closed the circuit. It appears the guy wire picked up current directly from the incandescent and transferred the current to the tree.

Mr. Campbell requested the Forestry Department send a crew to trim the tree limbs close to the incandescent circuit. This work was completed on October 18.

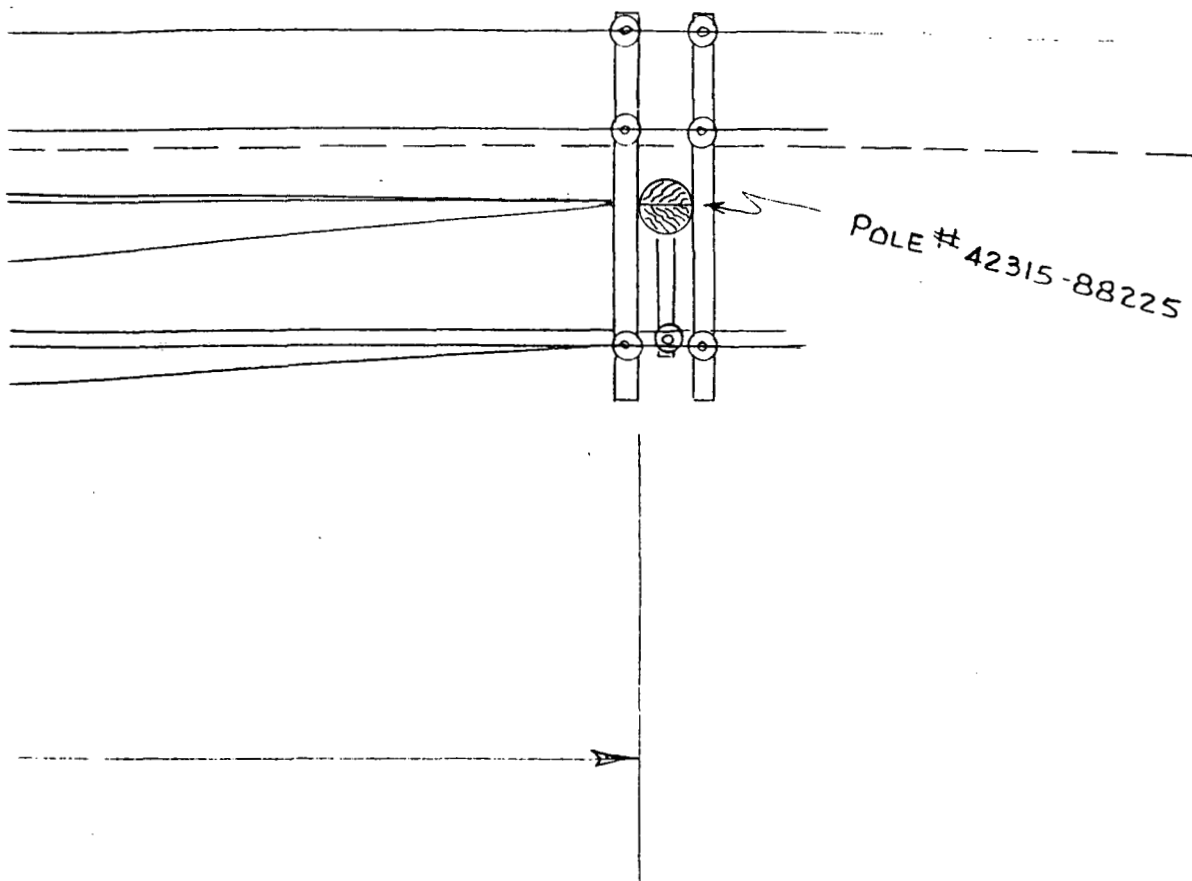
SKETCH SHOWING OVERHEAD VIEW OF
POLE # 42315-88225 & POLE # E2-2468
AT 1020 W. MARKET WHERE ACCIDENT
OCCURED TO CHARLES SHEARD 10-16-96
NO SCALE DRAWN BY R.W. HASCH

There are two trees involved in this incident. The larger tree, directly in front of 1020 West Market Street, is the one Mr. Sheard advises he touched, and a smaller tree, which is located just west. The larger tree has limbs which have grown into the incandescent wire. The smaller tree suffered fire damage on the evening of October 16. All that remains of the smaller tree is a burned stump. The fire department removed the rest of the tree on October 16. The concrete on the sidewalk surrounding the stump of the small tree contains several burn marks. According to Mr. Hasch, these are indicative of incandescent circuit voltage.

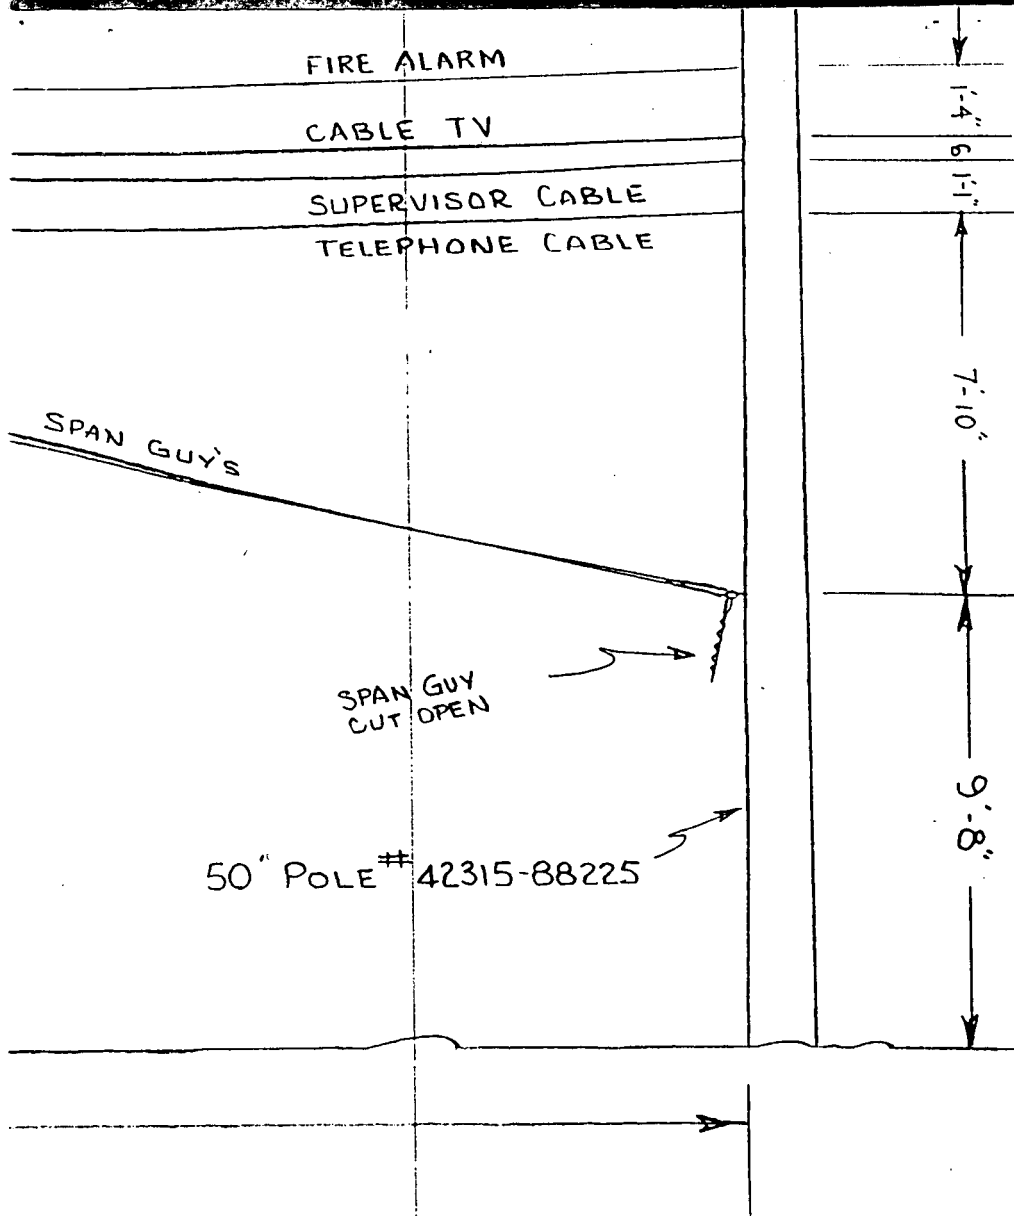
SKETCH SHOWING POLE # 42315-88225
AND POLE # E2-2468 IN FRONT OF
1020 W. MARKET ST. WHERE ACCIDENT
OCCURED TO CHARLES SHEARD 10-16-96
NO SCALE DRAWN BY R.W. HASCH

The following conditions were noted. A light standard located on the south side of Market Street between poles #E2-2467 and #E2-2512 had a disconnected wire on its west side. This wire is fed by an incandescent lighting circuit tab located on pole #E2-2468. This pole was in the process of being replaced and a new pole was set on the east side of it on October 16. Extension arms were attached to pole #E2-2468 to spread the wires (a normal procedure for pole replacement). The lower extension arm held the end of a 240 V secondary line, and a guy wire holding it in place. The other end of the guy was attached to pole #E2-2467 (where two other guy wires also attached from pole #E2-2468). The guy wire in question was removed on the evening of October 16 by Kevin Rhodes, Line Technician. LG&E's correction order #827859 states, "Found temporary head guy laying on incandescent circuit and burning on ground. Cleared up okay." (Note: Notation of "temporary" on correction order was an error. Head guy was permanent.)

The incandescent lighting circuit would not have been energized on October 16 until dark when the photocell closed the circuit. It appears the guy wire picked up current directly from the incandescent and transferred the current to the tree.

Mr. Campbell requested the Forestry Department send a crew to trim the tree limbs close to the incandescent circuit. This work was completed on October 18.
